4. TITLE (and Subtitle) Whiting River Dam  NATIONAL PROGRAM FOR INSPECTION OF NON-FEDERAL DAMS		5. TYPE OF REPORT & PERIOD COVERED INSPECTION REPORT
7. AUTHOR(s) U.S. ARMY CORPS OF ENGINEERS NEW ENGLAND DIVISION		6. PERFORMING ORG. REPORT NUMBER

NATIONAL PROGRAM OF  
INSPECTION OF  
NON-FED. DAMS

WHITING RIVER DAM
WHITING RIVER
NO. CANAAN, CONNECTICUT
CT 00483
17 NOV '80

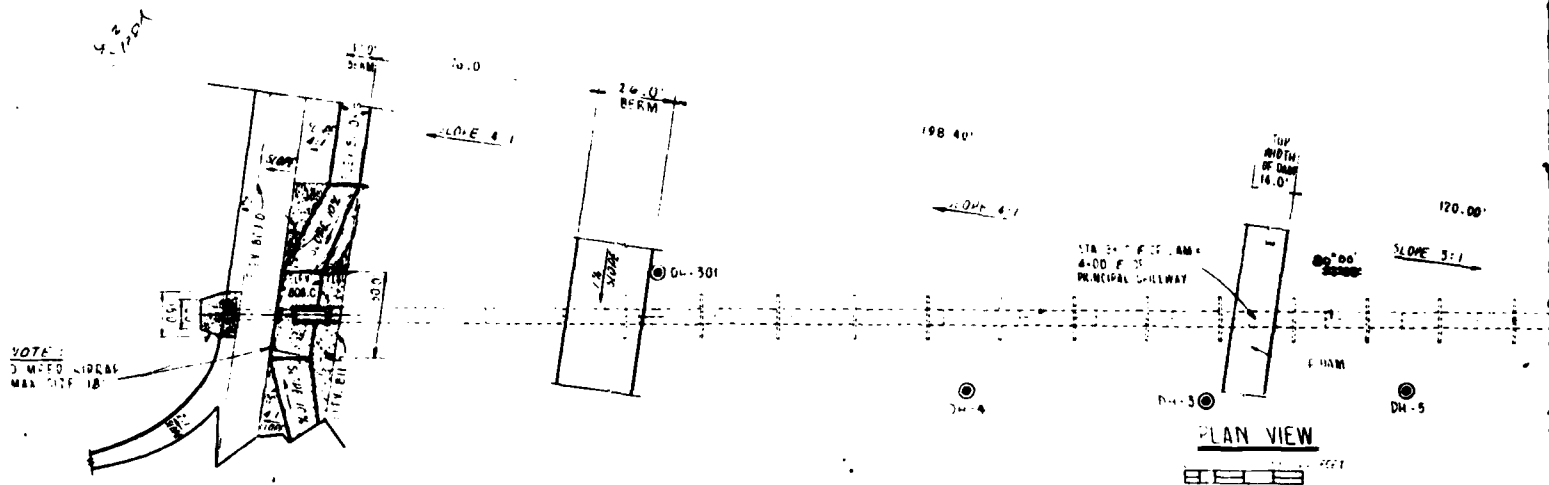
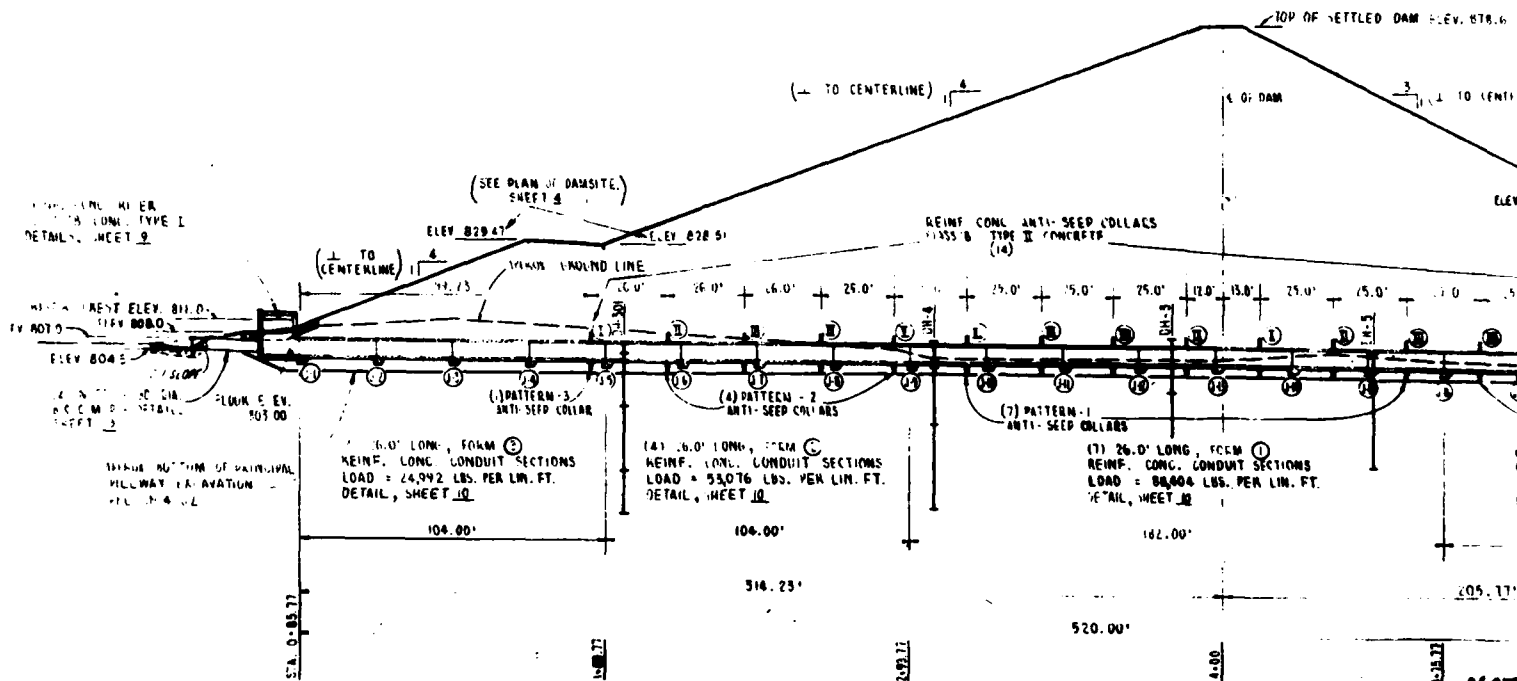
PROFILE ALONG & PRINCIPAL SPILLWAY

7/77 CONCRETE CRACKS 13.2' D.S. FROM J-15 AND 14'-16' D.S. FROM J-16

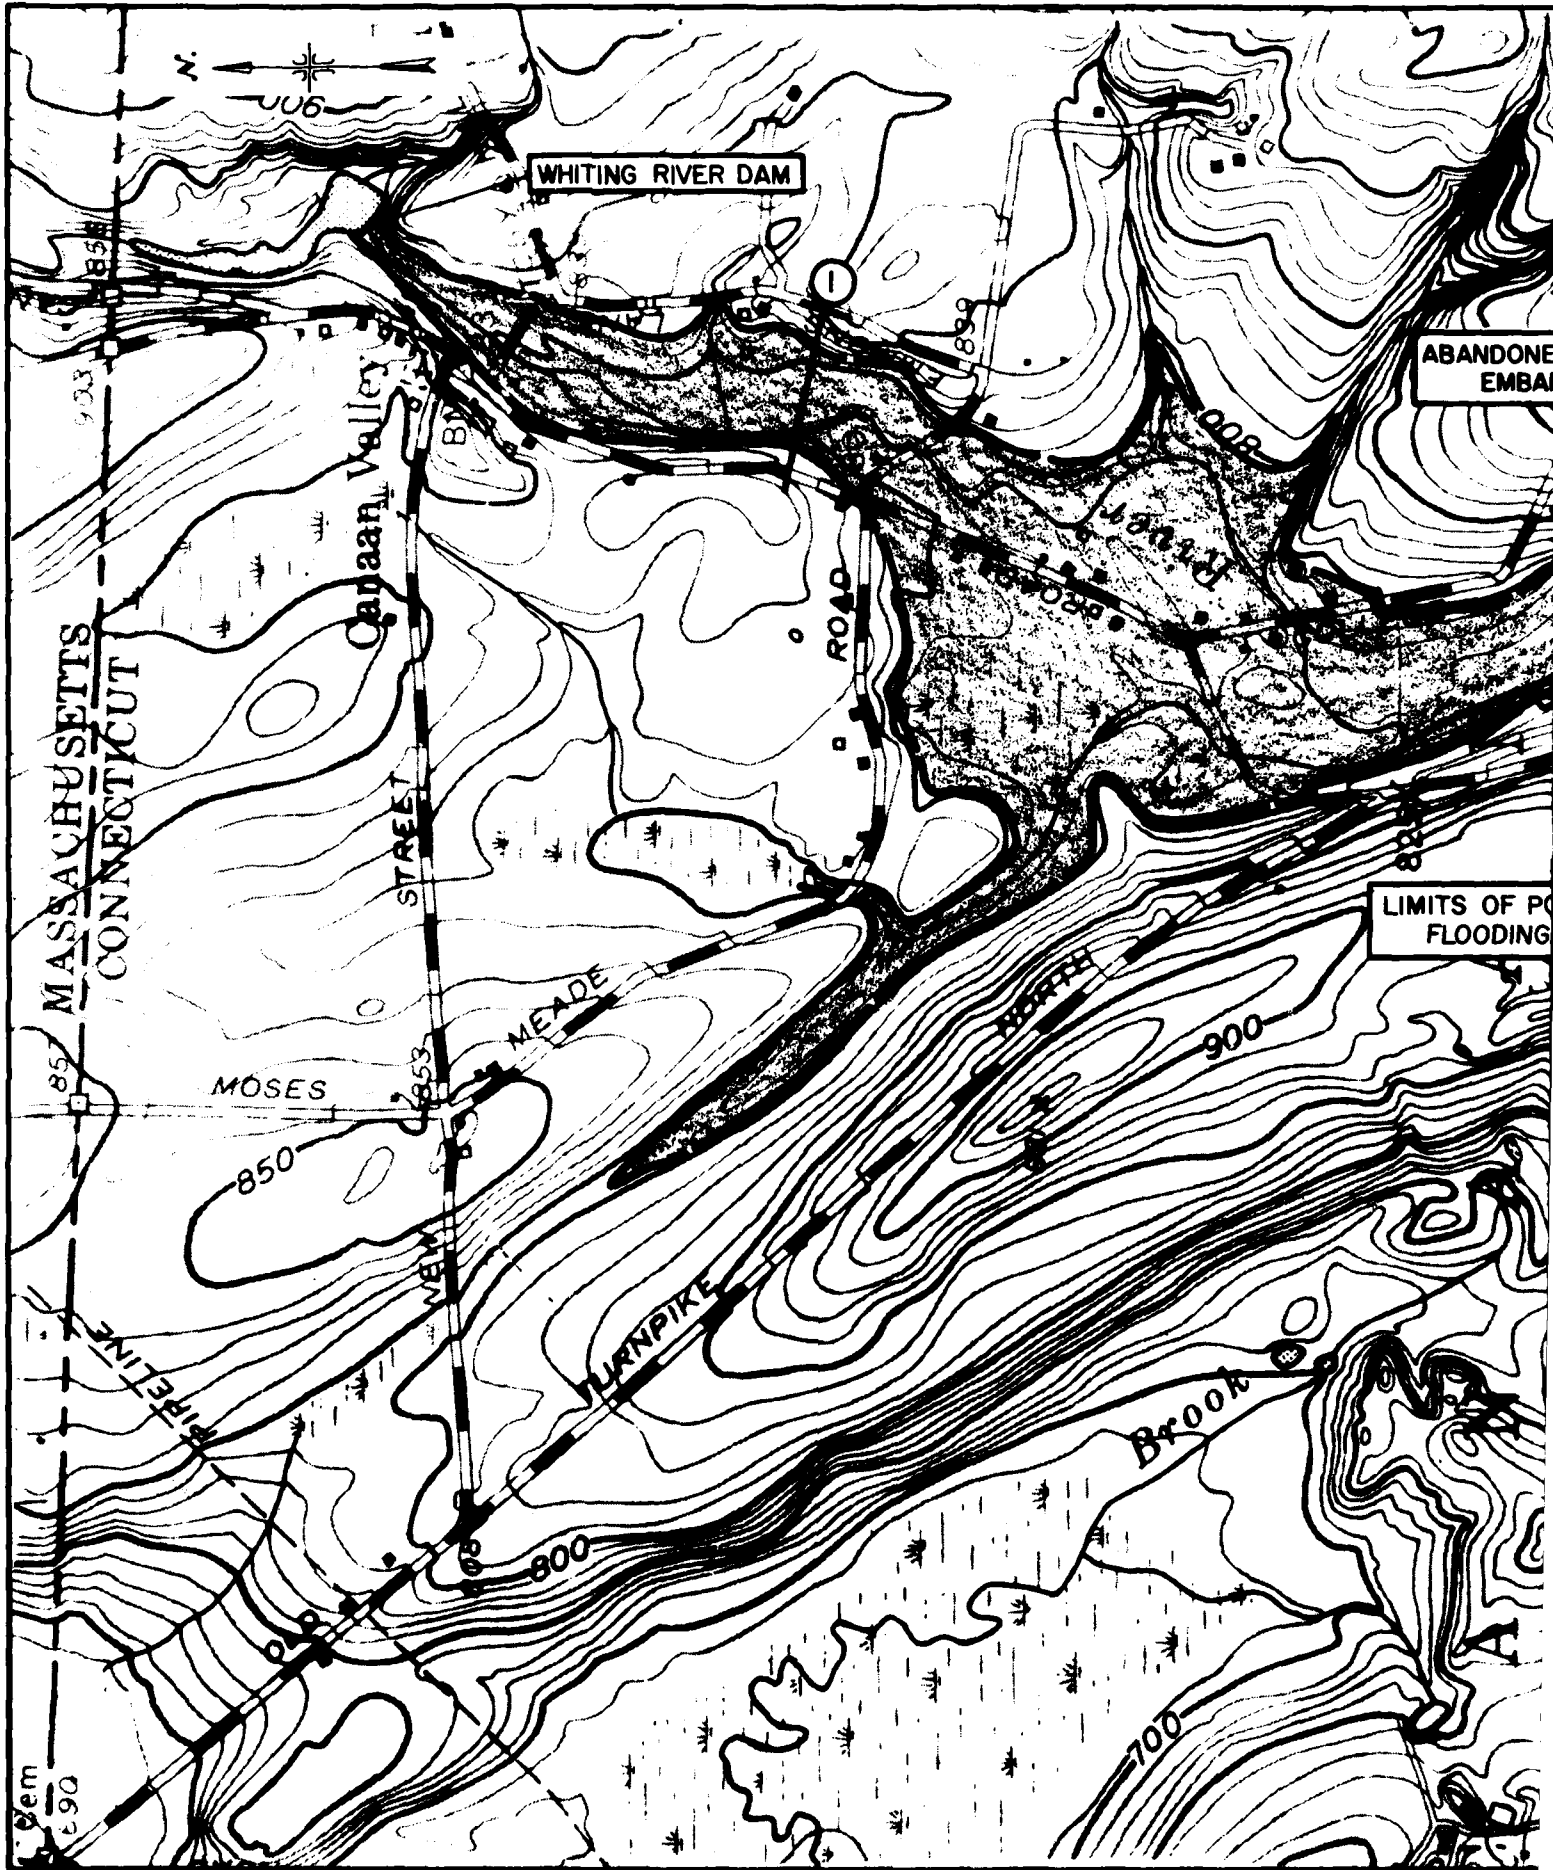
FIGURE 4

is present with an assumed 100 foot long slot through it. The embankment, assuming it did not fail, would limit the downstream discharge and cause the flood waters to pond upstream, inundating 10 - 15 homes up to a depth of 20 feet. Downstream of the railroad embankment the flood waters would overtop U.S. Route 44 and flood adjacent structures to a depth of up to 7 feet. See Figure 4, page D-19.
